NASA Technical Memorandum 74077

Evaluation of Three
Thermal Protection Systems in
a Hypersonic High-Heating-Rate
Environment Induced by
an Elevon Deflected 30°

Allan H. Taylor, L. Robert Jackson, and Irving Weinstein

DECEMBER 1977/

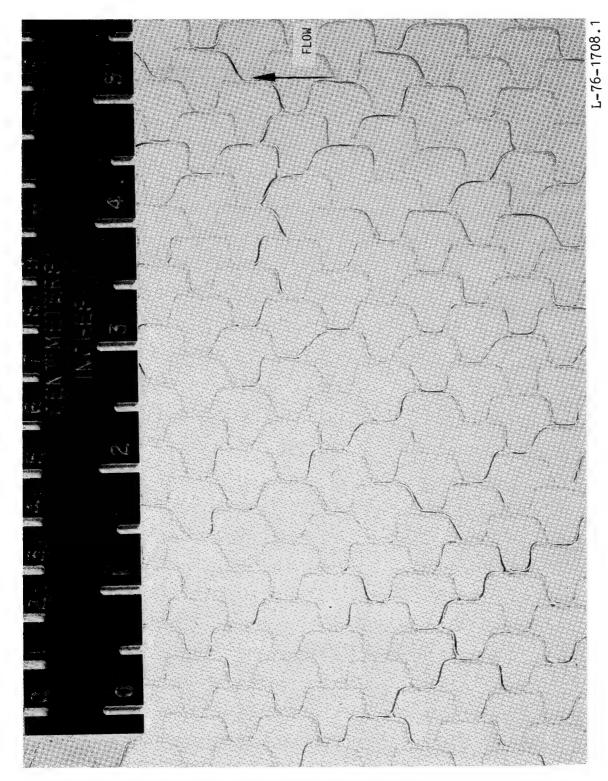
The honeycomb-reinforced insulator-ablator material as tested on the vehicle surface specimen is adequate for the low shear and heating rates experienced at low angles of incidence to the local flow. The cracking caused by the shrinkage of the material apparently does not degrade the capability of the thermal protection system. These cracks, however, may pose operational problems due to water entrapment.

Figure 8.- Shrinkage of the honeycomb-filled insulator-ablator cells.

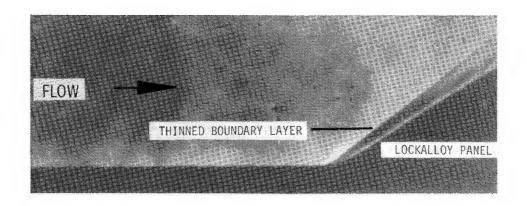
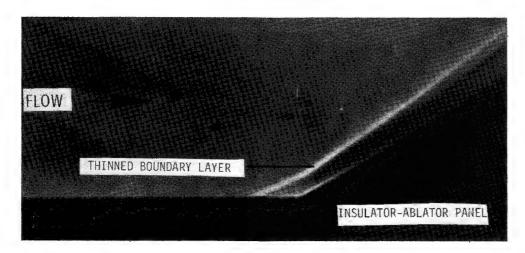
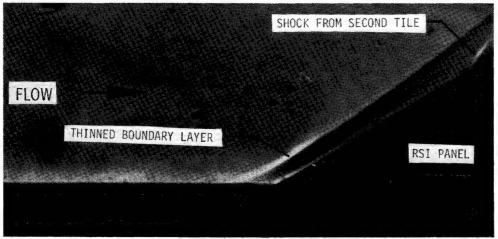
Schlieren photographs of all three test specimens are shown in figure 15. The top photograph was taken during the first Lockalloy test. A thinned boundary layer is visible just above the intersection of the panel holder and the elevon in each case. No shock impingement or flow separation is evident. The boundary layer is noticeably thicker in the lower two photographs, possibly due to either mass addition to the flow from the surface-panel specimen mounted ahead of these two specimens or the increased surface roughness of the pyrolyzed insulator-ablator panel over the stainless surface panel.

Figure 15.- Schlieren photographs of TPS tests.

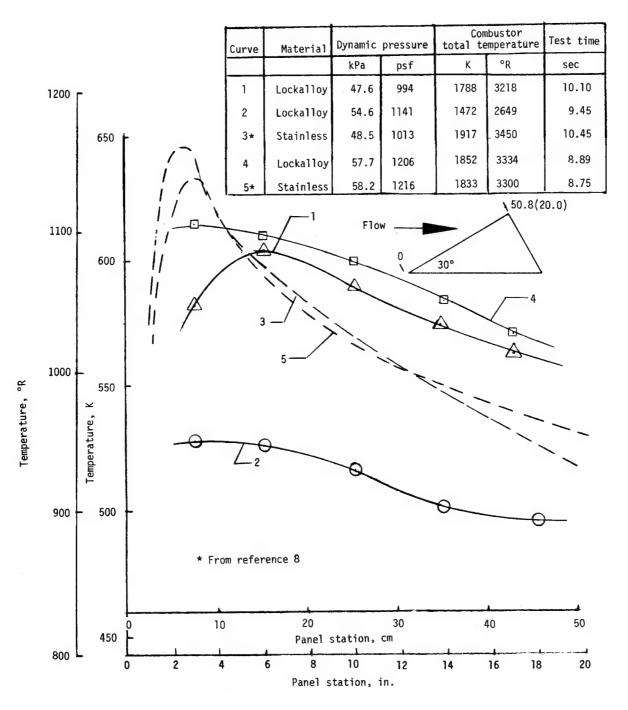
The Lockalloy specimen was tested under the conditions outlined in the first three tests of table I. The temperature distributions along the center line of the specimen are shown in figure 16 for all three tests. The temperature distributions are compared with similar tests of a 1.3-cm-thick (0.5-in.) stainless-steel specimen (ref. 8). The model was fully inserted in the stream for about 10 seconds on each test. It can be seen in the area of highest heating rate that the temperature spike is quite visible for the stainless-steel panel of reference 8, whereas the high conductivity of the Lockalloy dissipates the heat pulse and holds a nearly uniform temperature throughout the panel in The maximum temperature difference on the face of the Lockalloy panel was never greater than 56 K (100° R). Figure 17 is a photograph of the Lockalloy specimen after the third test. The only discernible difference between this photograph and that taken prior to the testing is the local removal of small areas of paint caused by impacts from debris in the flow stream. At about 7.6 cm (3 in.) aft of the hinge line on both sides a small area of Lockalloy was completely bared due to the high local temperature and shear removing the paint. Bluing of the side skirt also suggests higher heating in this area.

Figure 16.- Comparison of temperature distributions along length of test panels.

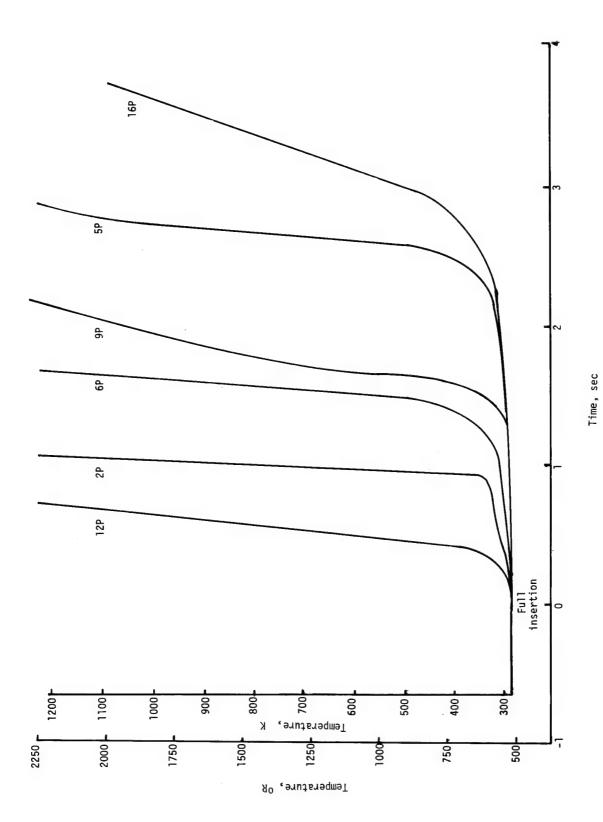
Only one test (test 4 of table I) was made on the insulator-ablator specimen, and the test parameters are listed in table I. Shortly after insertion into the stream the surface thermocouples indicated an extremely rapid temperature rise (fig. 18). This indicates that the 0.3-cm-thick (0.12-in.) layer of insulator ablator over these thermocouples was removed by this time. The two surface thermocouples in the highest heating-rate area near the hinge line, locations 12P and 2P in figure 4 were apparently exposed first. The surface degradation followed rapidly up the elevon. All surface thermocouples were exposed in less than 3 seconds. This indicates that one-fifth of the 1.5-cmthick (0.6-in.) material was removed at these locations after this short exposure time. Backface thermocouple readings are presented in figure 19. backface (BF) temperature starts to rise after a 2-second exposure. After 8 seconds the temperature rise rate is quite high, over 56 K (100 $^{\rm O}$ R) per sec-The lowest rates were observed on the thermocouples that remained in place ond. under the honeycomb material. These are designated 15BF and 13BF in figure 19.

Figure 18.- Surface thermocouple readings during the insulator-ablator test.

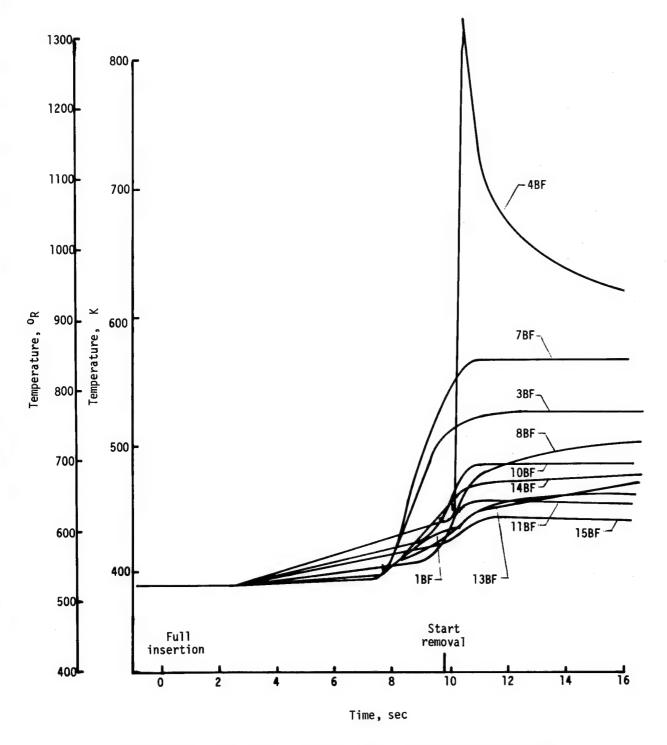
The maximum acceptable operating temperature for aluminum is 422 K (760° R). (See ref. 10.) At this temperature aluminum has only 80 percent of its room-temperature properties, and the properties fall off quite rapidly beyond this temperature. As can be seen from figure 19, only the backface readings under the honeycomb-filled material were under 422 K (760° R) at the end of 10 seconds.

Figure 19.- Backface (BF) thermocouple readings during the insulator-ablator test.

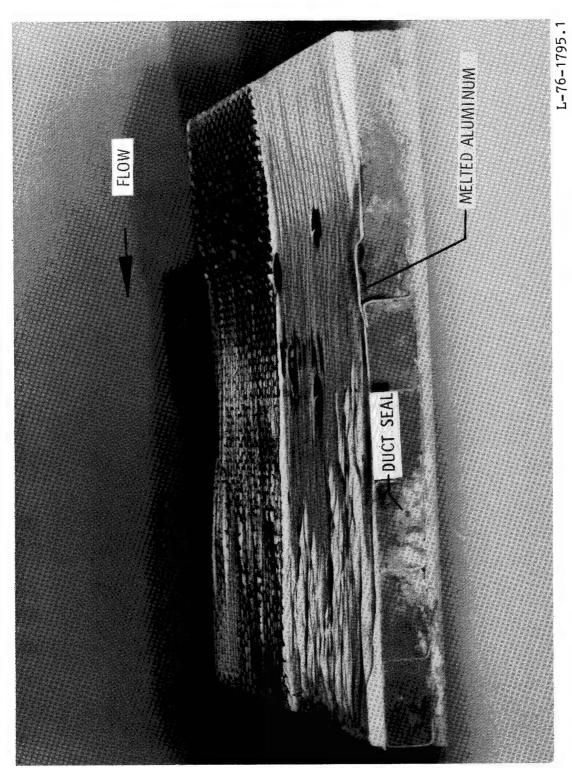
The mode of failure of the insulator ablator is also unique. The material was expected to ablate under high-heat loads; however, in this test the virgin material apparently sheared away before reaching ablation temperatures. Figure 20 is a photograph of the panel following the test. A large quantity of the material has been removed and incipient melting of the aluminum substructure is evident in several locations. The photograph in figure 21 is a closeup view of the trailing edge of the panel showing the relative performance of the two insulator-ablator materials. Virgin material is evident in both the striated The striated material shows the characteristic and honevcomb-filled materials. grooving along the slits which continue aft into the unstriated thickness. honeycomb-reinforced material shows little charring and is pyrolyzed near the leading-edge hinge line. Less than 2.5 cm (1 in.) from the leading edge the honeycomb cells show evidence of severe charring and the insulator still exhibits pyrolization. However, further up the panel the virgin material is again visible, surrounded by the severely charred honeycomb core. The charring of honeycomb core is not as severe at the aft end as it is near the leading edge. Also, the core improves the shear resistance of the material.

Figure 20.- Insulator-ablator specimen after testing.

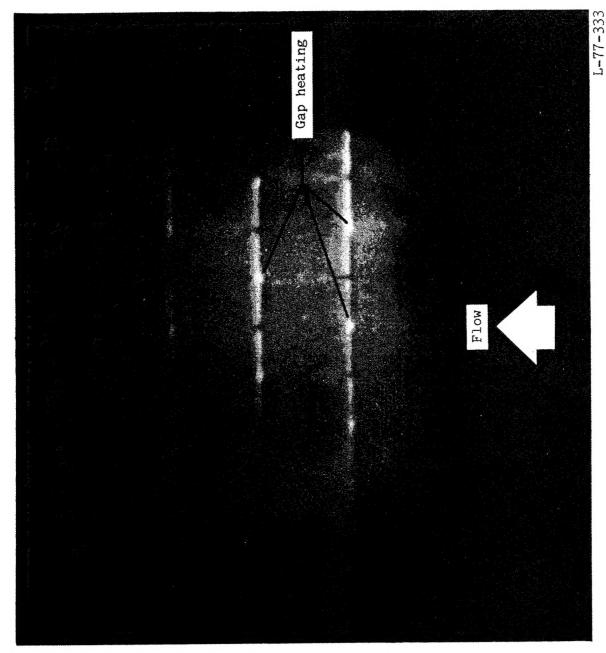
The silica RSI specimen was subjected to an environment similar to that of the Lockalloy and insulator ablator. Figure 23 is a photograph of the specimen in the test stream during the test. The light areas indicate that the surface of the RSI is heated. The brightest areas are caused by the higher temperatures induced by flow in the gaps where the tile walls are not free to cool by radiation. The gap flow is impinging on the leading edge of the downstream tile because of the staggered joints. This impingement causes higher local heating as indicated by the brightest areas in line with the gaps.

Figure 23.- The RSI specimen in test stream showing areas of heating.

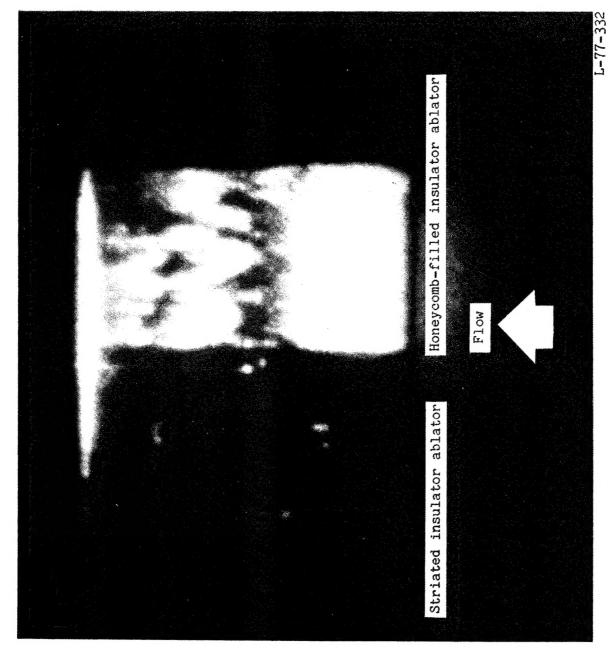
Figure 22 is a photograph of the specimen in the test stream approximately halfway through the test. The bright areas indicate high-temperature locations. In these locations the material has reached radiation equilibrium temperature. However, most of the area is dark, indicating that the material has not reached radiation equilibrium temperature. This can be caused by material erosion most probably initiated by the high shear forces created in the flow before the material could be heated to radiation equilibrium temperature. This is the apparent cause since a significant amount of the remaining insulator ablator is virgin unpyrolized material.

Figure 22 also shows the heating at the top edge which is more pronounced near the center of the panel. The heating rate in the corners was apparently less than that near the center, and erosion of the material at the trailing edge is more severe near the center.

Figure 22.- Insulator-ablator specimen in test stream showing areas of heating.

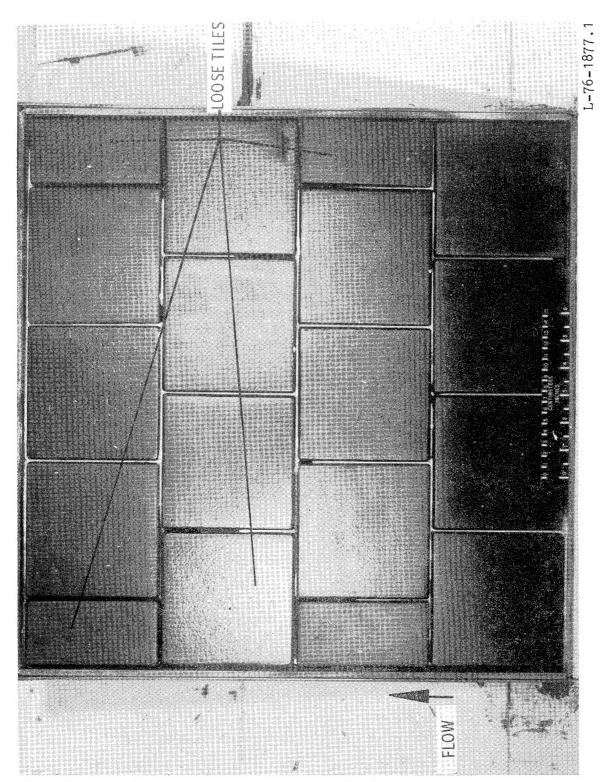
A posttest photograph of the model is shown in figure 24. Some minor pitting of the RSI coating is noted. This is assumed to be the result of debris in the flow stream, which would not be representative of real flight conditions. Also, some inter-tile batting has been removed, and the remaining peripheral and inter-tile batting is visible. Inspection of the panel after testing revealed that four tiles were loose. The backface thermocouple readings did not rise appreciably during the test.

Four RSI tiles were partially debonded after testing and considerable joint packing was lost, thus indicating a need to develop a better packing and edge seal to avoid gap flow. This gap flow may cause thermal strains in the substrate which in itself could promote the bond failure. The debonding of the RSI tiles did not degrade its thermal performance. Some pitting of the coating of the tiles was precipitated by particle impacts.

Figure 2^{μ} . Damage of RSI specimen after testing.

The RSI material effectively insulated the aluminum panel from the deflected elevon environment. However, the four loose tiles would require some maintenance and the batting between the tiles would require either replacement, especially in the streamwise direction, or a better means of retention.
